DEPARTMENT OF TRANSPORTATION**DIVISION OF ENGINEERING SERVICES**

Contract #: 04-0120F4Cty: SF/ALA Rte: 80 PM: 13.2/13.9File #: 1.28**WELDING INSPECTION REPORT****Resident Engineer:** Casey, William**Address:** 333 Burma Road**City:** Oakland, CA 94607**Report No:** WIR-027797**Date Inspected:** 20-Jun-2012**Project Name:** SAS Superstructure**OSM Arrival Time:** 700**Prime Contractor:** American Bridge/Fluor Enterprises, a JV**OSM Departure Time:** 1730**Contractor:** American Bridge/Fluor Enterprises, a JV**Location:** Job Site**CWI Name:** William Sherwood**CWI Present:** Yes No**Inspected CWI report:** Yes No N/A**Rod Oven in Use:** Yes No N/A**Electrode to specification:** Yes No N/A**Weld Procedures Followed:** Yes No N/A**Qualified Welders:** Yes No N/A**Verified Joint Fit-up:** Yes No N/A**Approved Drawings:** Yes No N/A**Approved WPS:** Yes No N/A**Delayed / Cancelled:** Yes No N/A**Bridge No:** 34-0006**Component:** SAS Tower**Summary of Items Observed:**

WELDING INSPECTION REPORT

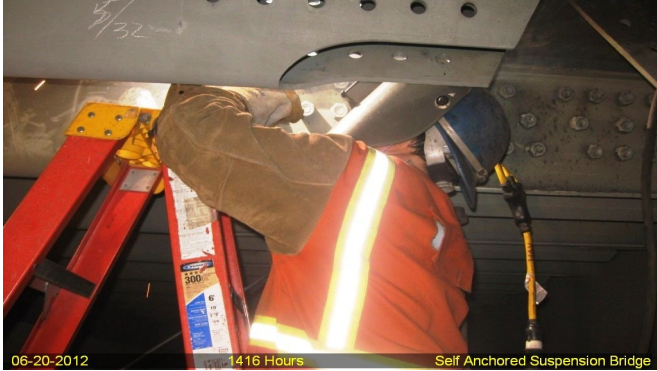
At OBG 13W-W2.5 @ 5030 top deck drop-in plate inside, ABF welder Wen Han Yu was observed performing 4G (overhead) position Shielded Metal Arc Welding (SMAW) back welding cover pass on butt joint.

At OBG 3W-W2.5 @ 5030 location Y=0mm to 1850mm top deck drop-in plate butt joint inside, QA randomly observed ABF certified welder Han Wen Yu perform 4G (overhead position) Shielded Metal Arc Welding (SMAW) back welding cover pass on the CJP SPCM butt joint. The welder was utilizing 4.0mm diameter E7018H4R electrode implementing Caltrans approved Welding Procedure Specification (WPS) ABF-WPS-D15-1040C-CU. The joint being welded had a single V-groove butt joint with copper plate backing bar that was originally welded from the top using a combination of SMAW and Submerged Arc Welding (SAW) then removed the copper backing plate using carbon air arc gouging and ground smooth. The plates were preheated to more than 150 degree Fahrenheit using Miller Proheat 35 Induction Heating System prior welding. Welding parameters were monitored by ABF/QC William Sherwood. QA noted the working welding parameters of 150 amperes on the 4.0mm diameter E7018H4R electrode. The workmanship and appearance of the completed cover pass deemed satisfactory. During the shift, cover pass back welding on area mentioned above was completed.
